# Contaminated Aircraft Takeoff Test for the 1997/98 Winter

**Transportation Development Centre**

APS AVIATION INC. **APS**

December 1998

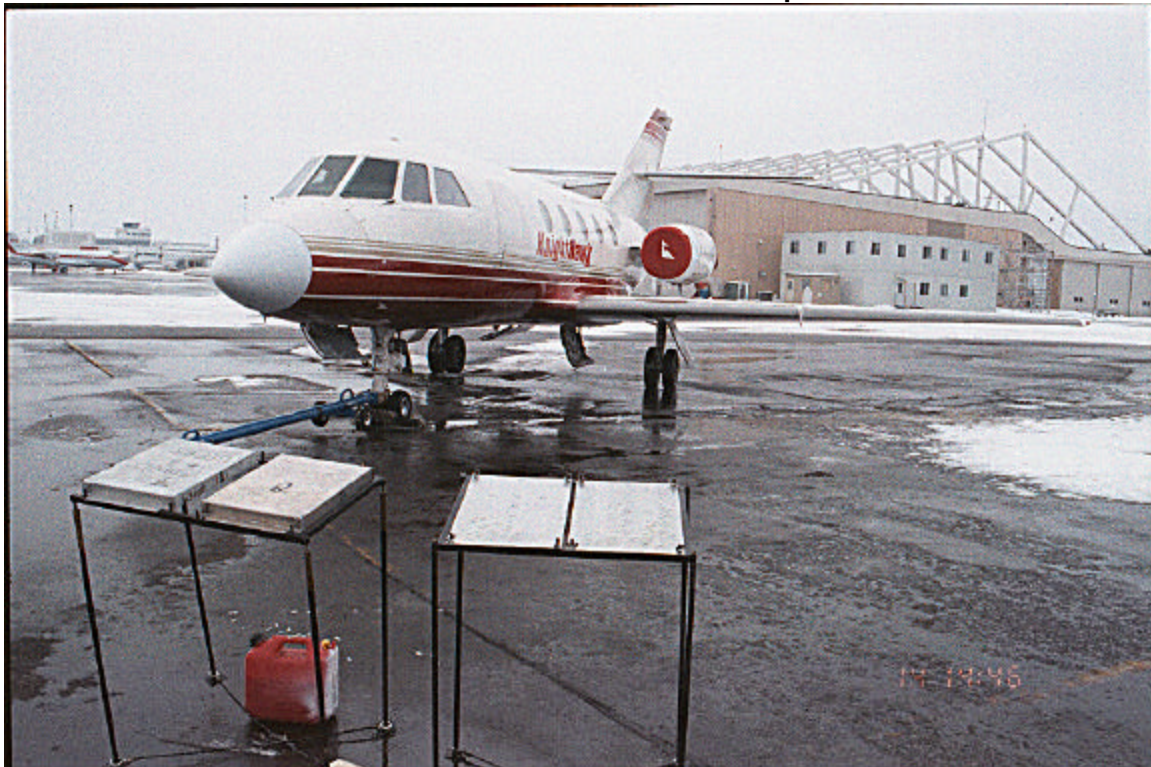
Photo 2.2  
Falcon 20D Static Test Setup

Equipment used was the same as defined in the program to determine fluid failure patterns on full-scale aircraft<sup>1</sup>. A portable plate-stand (Photo 2.2) was used for simultaneous flat plate tests.

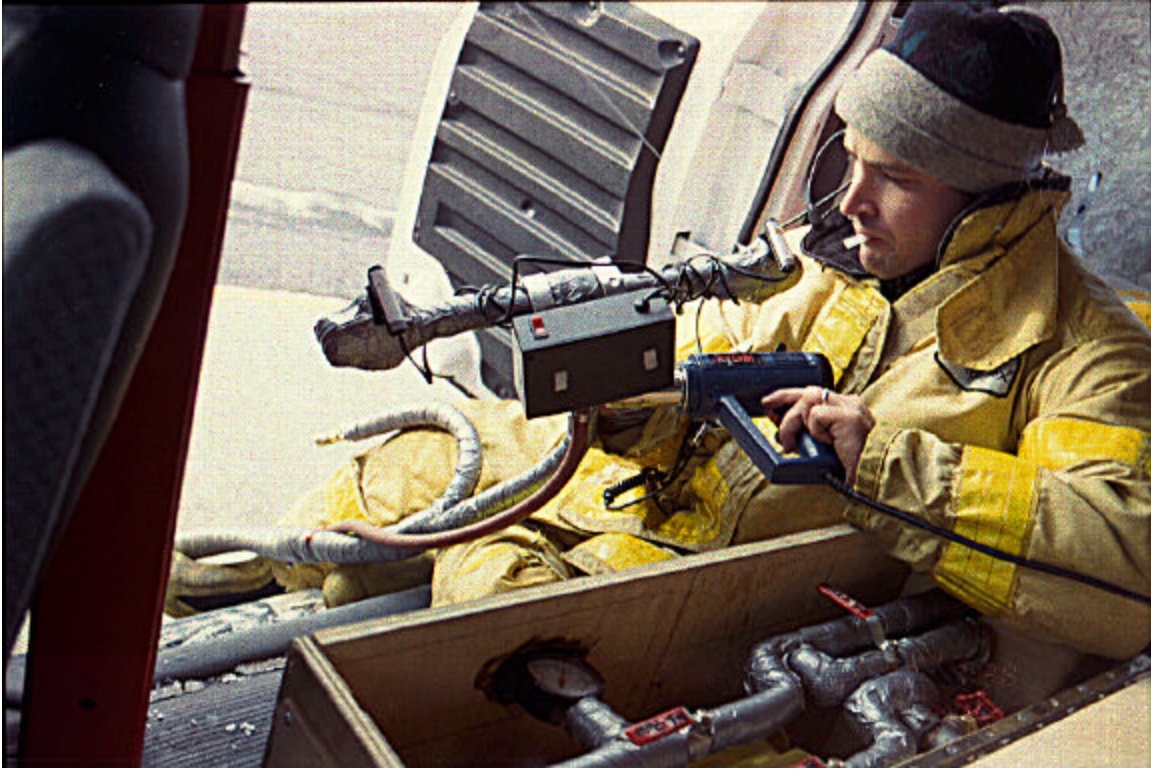
Photo 2.7  
Water Spray Bar

Evaluation trials conducted at the APS test site prior to the aircraft tests demonstrated that rates typical of freezing rain could be achieved using the portable unit. As the spray bar was hand-held and manipulated by an operator to provide coverage over the desired area, rates and consistency of coverage were operator dependent. For these trials, a single operator was used who developed a satisfactory level of skill. Calm wind conditions were necessary in order to achieve satisfactory coverage.

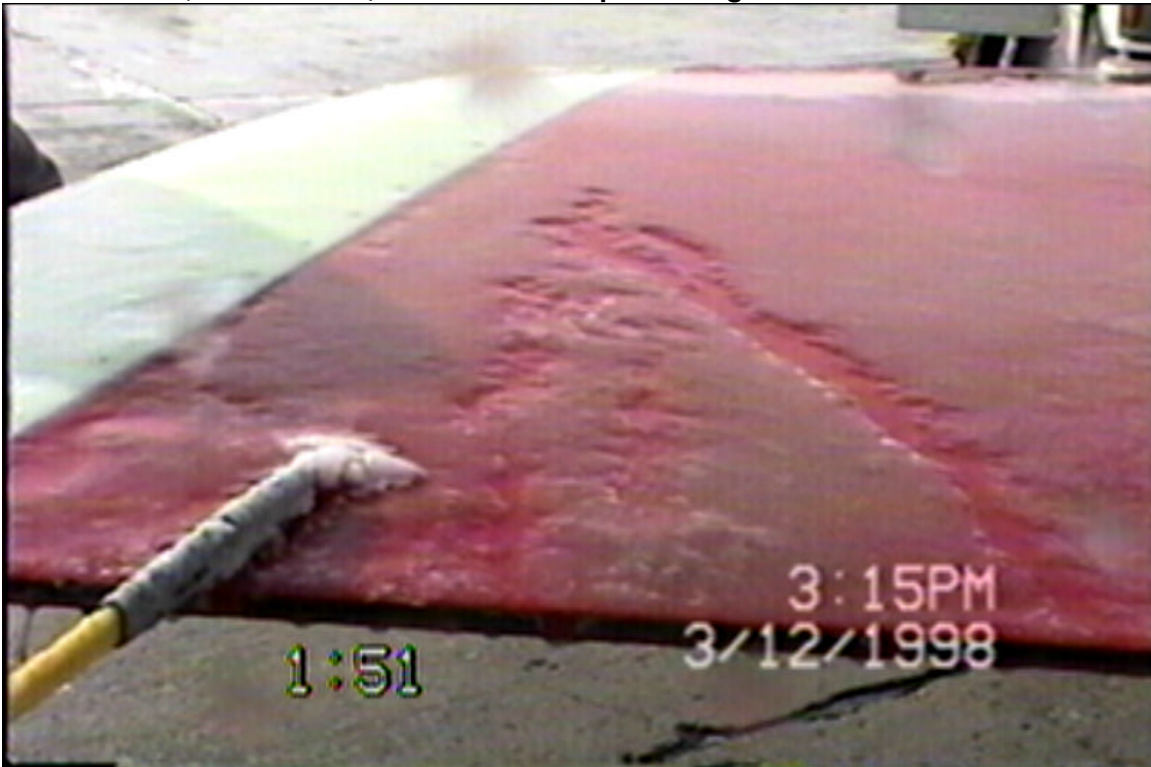
Photo 4.6  
Run 3 (33% Failure) Slush Over Top of Wing - Prior to Takeoff Run

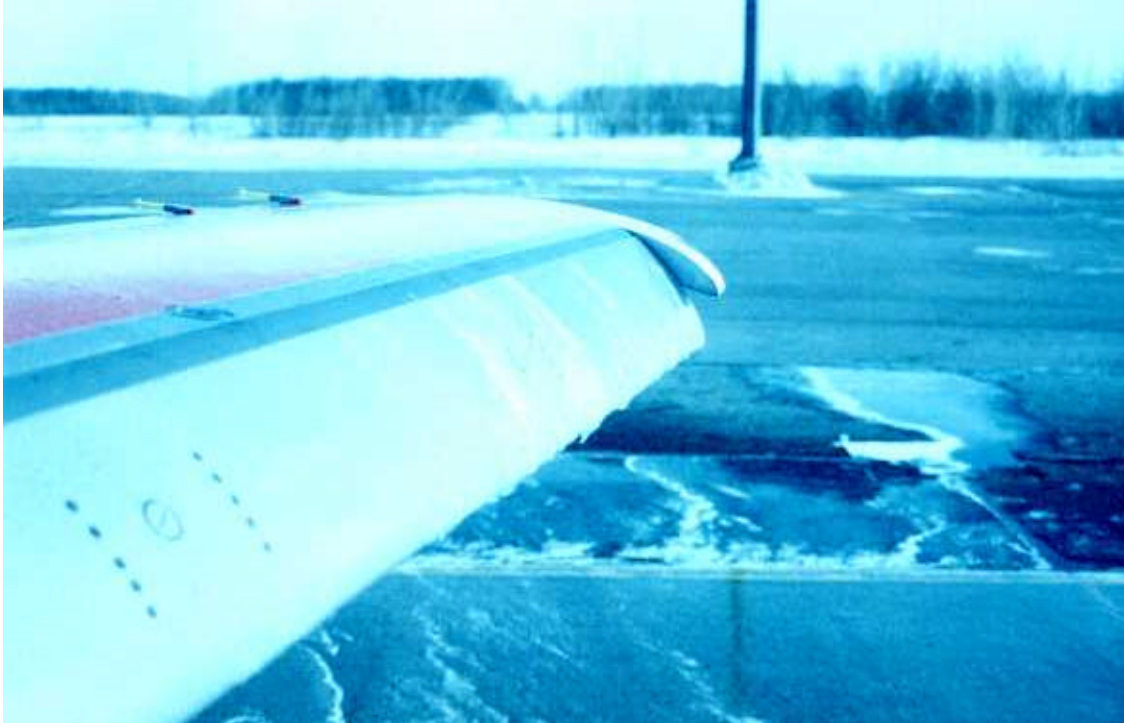
Photo 4.9  
Run 3 (33% Failure) Ice on Extended Leading Edge Slat – Following Takeoff Run
